REPORT No. T 6/59

OPERATION ANTLER

The Effects of Blast on Dummies and Scout Cars

August, 1959

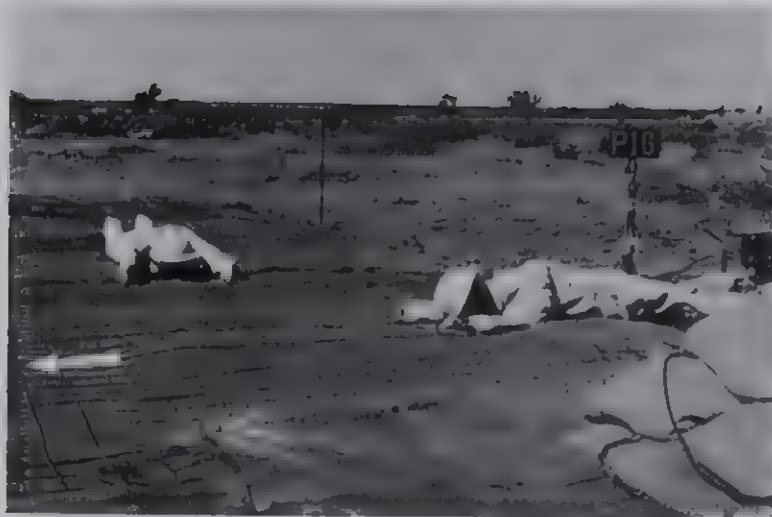
FIGURE 6. ROUND 2. PRONE DUMMIES AT 2000 ft BEFORE FIRING.
NOTE SEALED SURFACE OF WIRE MESH ON TARPAULINS
SECURED BY STAKES

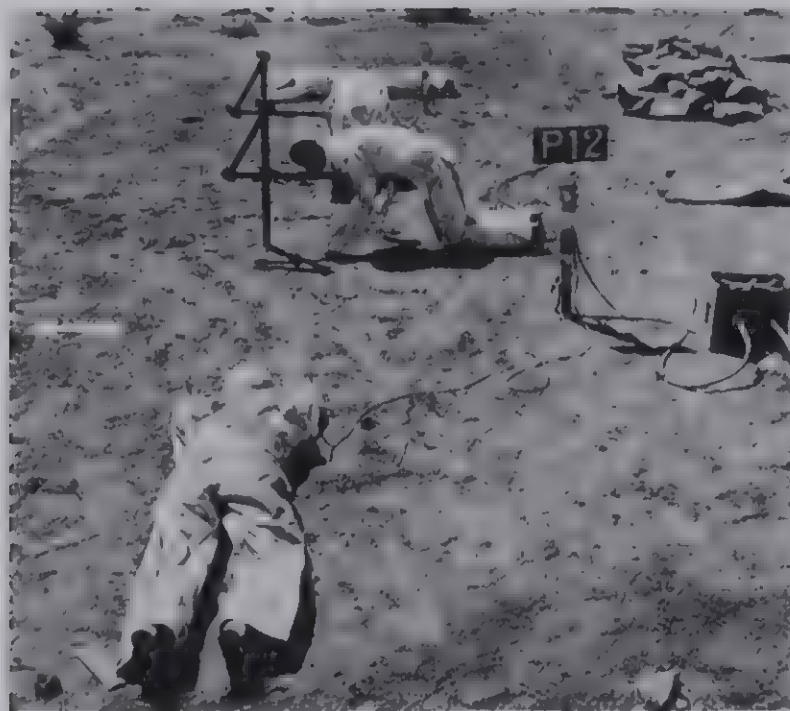
FIGURE 8. ROUND 2. PRONE AND CROUCHING DUMMIES AT 2200 ft BEFORE FIRING. NOTE INSTRUMENTATION LIABLE TO CATCH IN FEET. SANDBAGS WERE REMOVED BEFORE FIRING

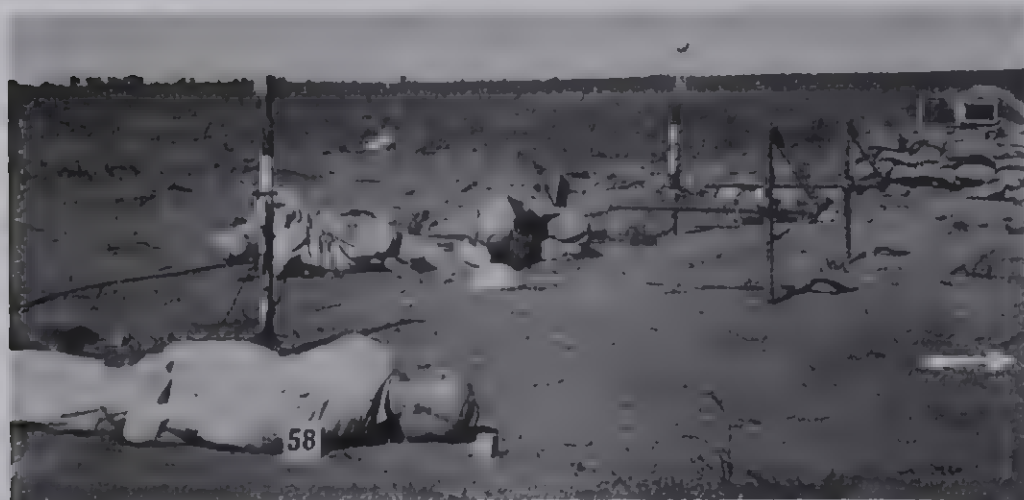
FIGURE 9. ROUND 2. DUMMIES AT 2200 ft. NOTE WHITE NAILS IN FRONT OF PRONE FACING DUMMY USED AS A REFERENCE MARK

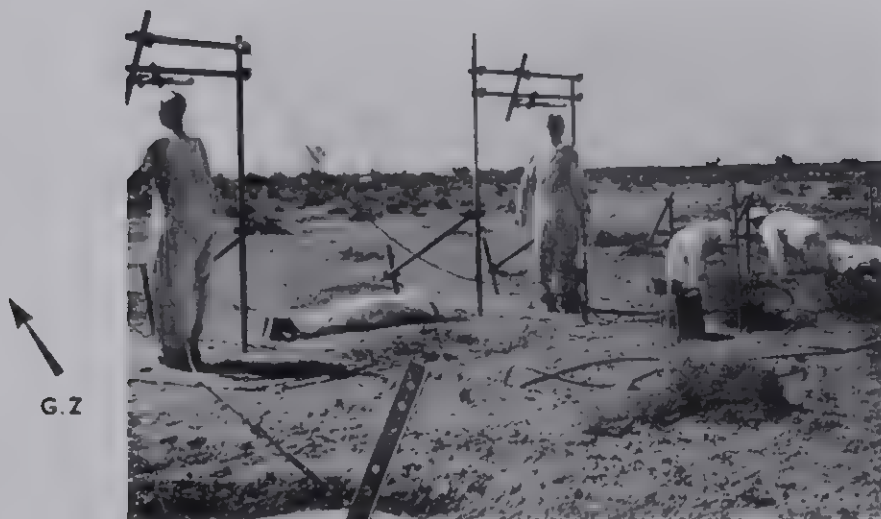
FIGURE 10. ROUND 2. DUMMIES AT 2390 ft BEFORE FIRING.
NOTE SCAFFOLDING USED TO SUPPORT DUMMIES

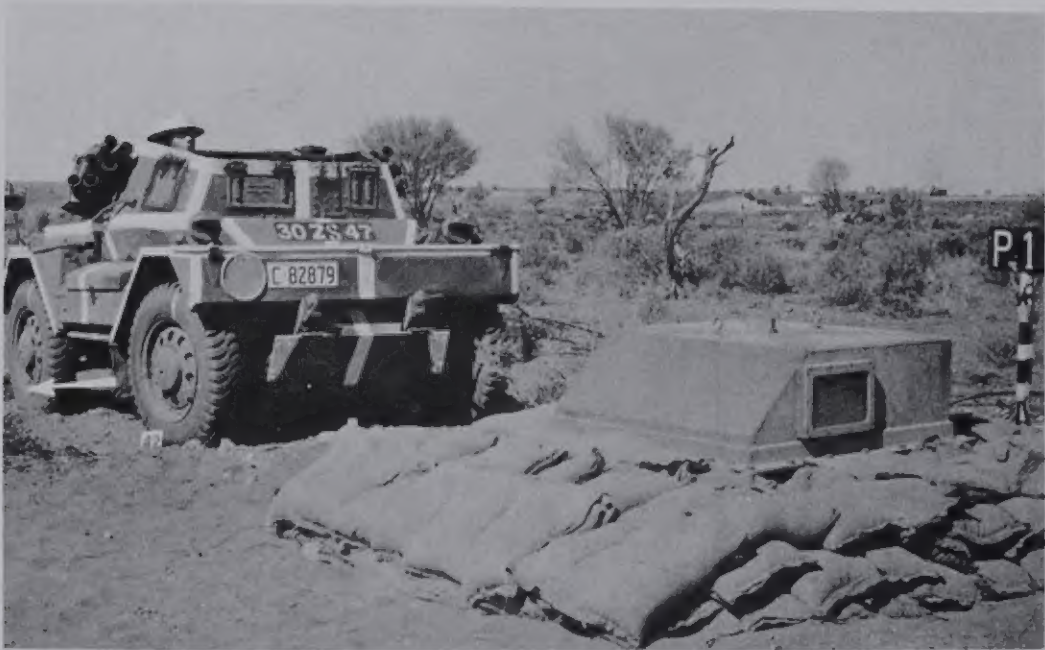
Because the yield of Round 2 was designed to be lower than had been assumed in the initial planning, the Daimler Scout Cars were not subjected to a large enough blast pressure for them to be greatly affected. Only the leading car at 1730 ft from Ground Zero had moved at all significantly. This car turned onto its side, spilling its dummy driver onto the ground, but did not undergo any actual translation. All the cars could be driven away after exposure. In the other cars at 2200, 2530 and 2650 ft movement was only a few inches and the dummy drivers were not affected. Details are shown in Appendix C and Figures 20, 21 and 22.

FIGURE 20. ROUND 2. SCOUT CAR AT 1730 ft BEFORE FIRING.
THIS ALSO GIVES GOOD VIEW OF TERRAIN IN THE
TARGET AREA

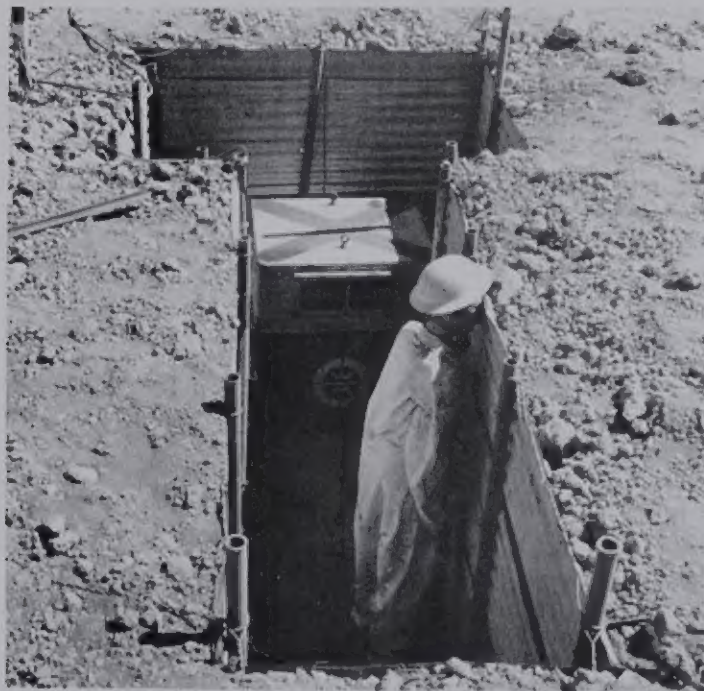
On Round 2, one dummy was standing in a trench which was at right angles to the radius from Ground Zero at Site P17 (2390 ft). The dummy was facing Ground Zero with the rim of its steel helmet about level with the lip of the trench (see Figure 23). This dummy was exposed primarily to test a camera installation, but after firing it was observed that it had not moved and had apparently suffered no damage (see Figure 24).

FIGURE 23. DUMMY IN TRENCH AT 2390 ft BEFORE FIRING
